# The Pokagon Band's Dowagiac River Restoration: A Tribal Wetland Project with a Decade of Progress

## RESTORING THE DOWAGIAC RIVER ON TRIBAL LANDS

# Dowagiac River Mainstem Restoration

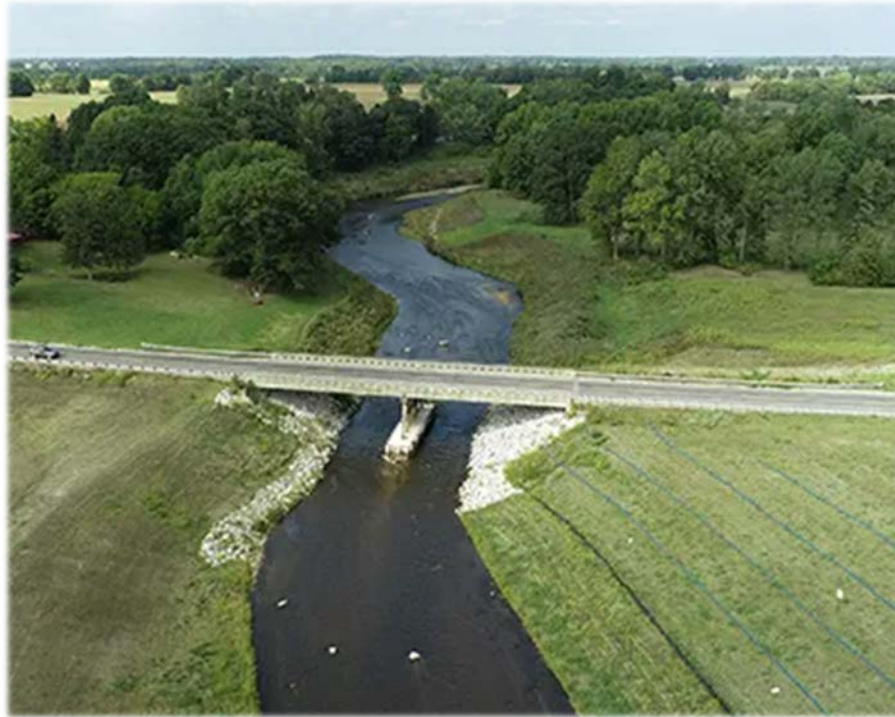
# Pucker Street Dam Removal

- Dam Removal Finalized in 2021
  - Re-connection of 159 miles of streams and tributaries

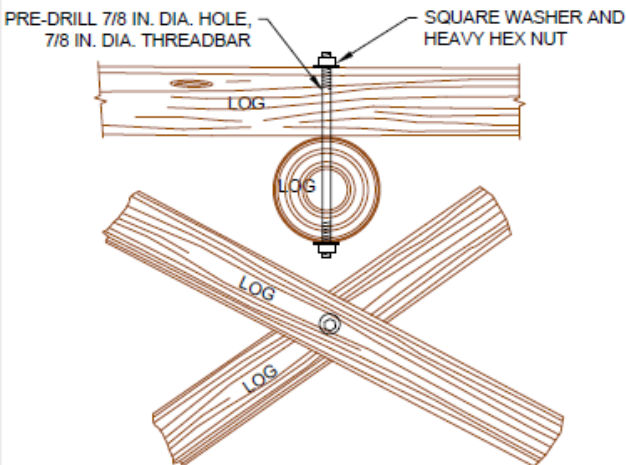
1  
15 BOLTED (THREADBAR) CONNECTION  
NOT TO SCALE

1. DRILL 7/8" DIA HOLE THROUGH LOGS.
2. INSERT 7/8" DIA THREADBAR.
3. INSTALL STEEL PLATES AND HEAVY HEX NUTS. SECURE NUTS BY CHISELING THREADS OR MUSHROOMING EXPOSED ENDS OF ROD.
4. FILE OR GRIND OFF SHARP EDGES.

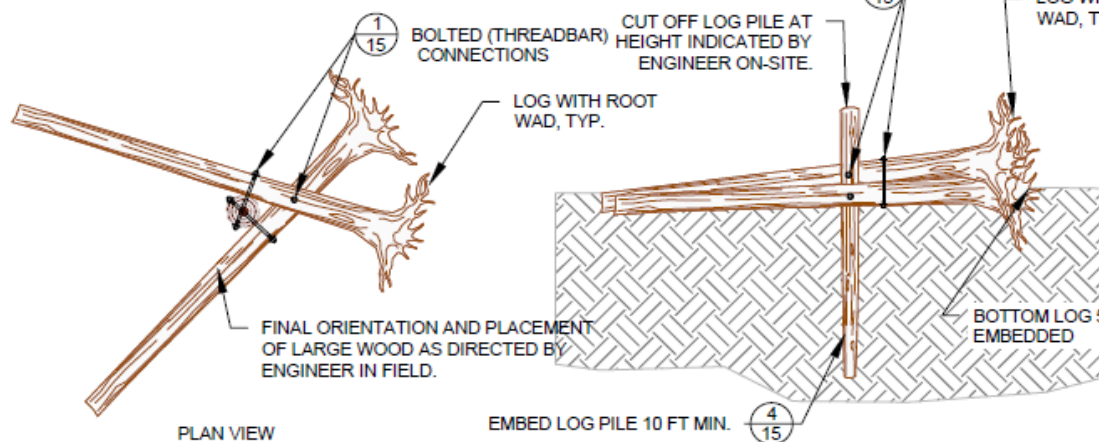
2  
15 FLOODPLAIN LARGE WOOD - 2 PIECE WITH 1 LOG PILE  
NOT TO SCALE

1. LARGE WOOD IS A FIELD SET ITEM.
2. FINAL LOCATIONS AND ORIENTATIONS OF LARGE WOOD TO BE INDICATED BY ONSITE ENGINEER.

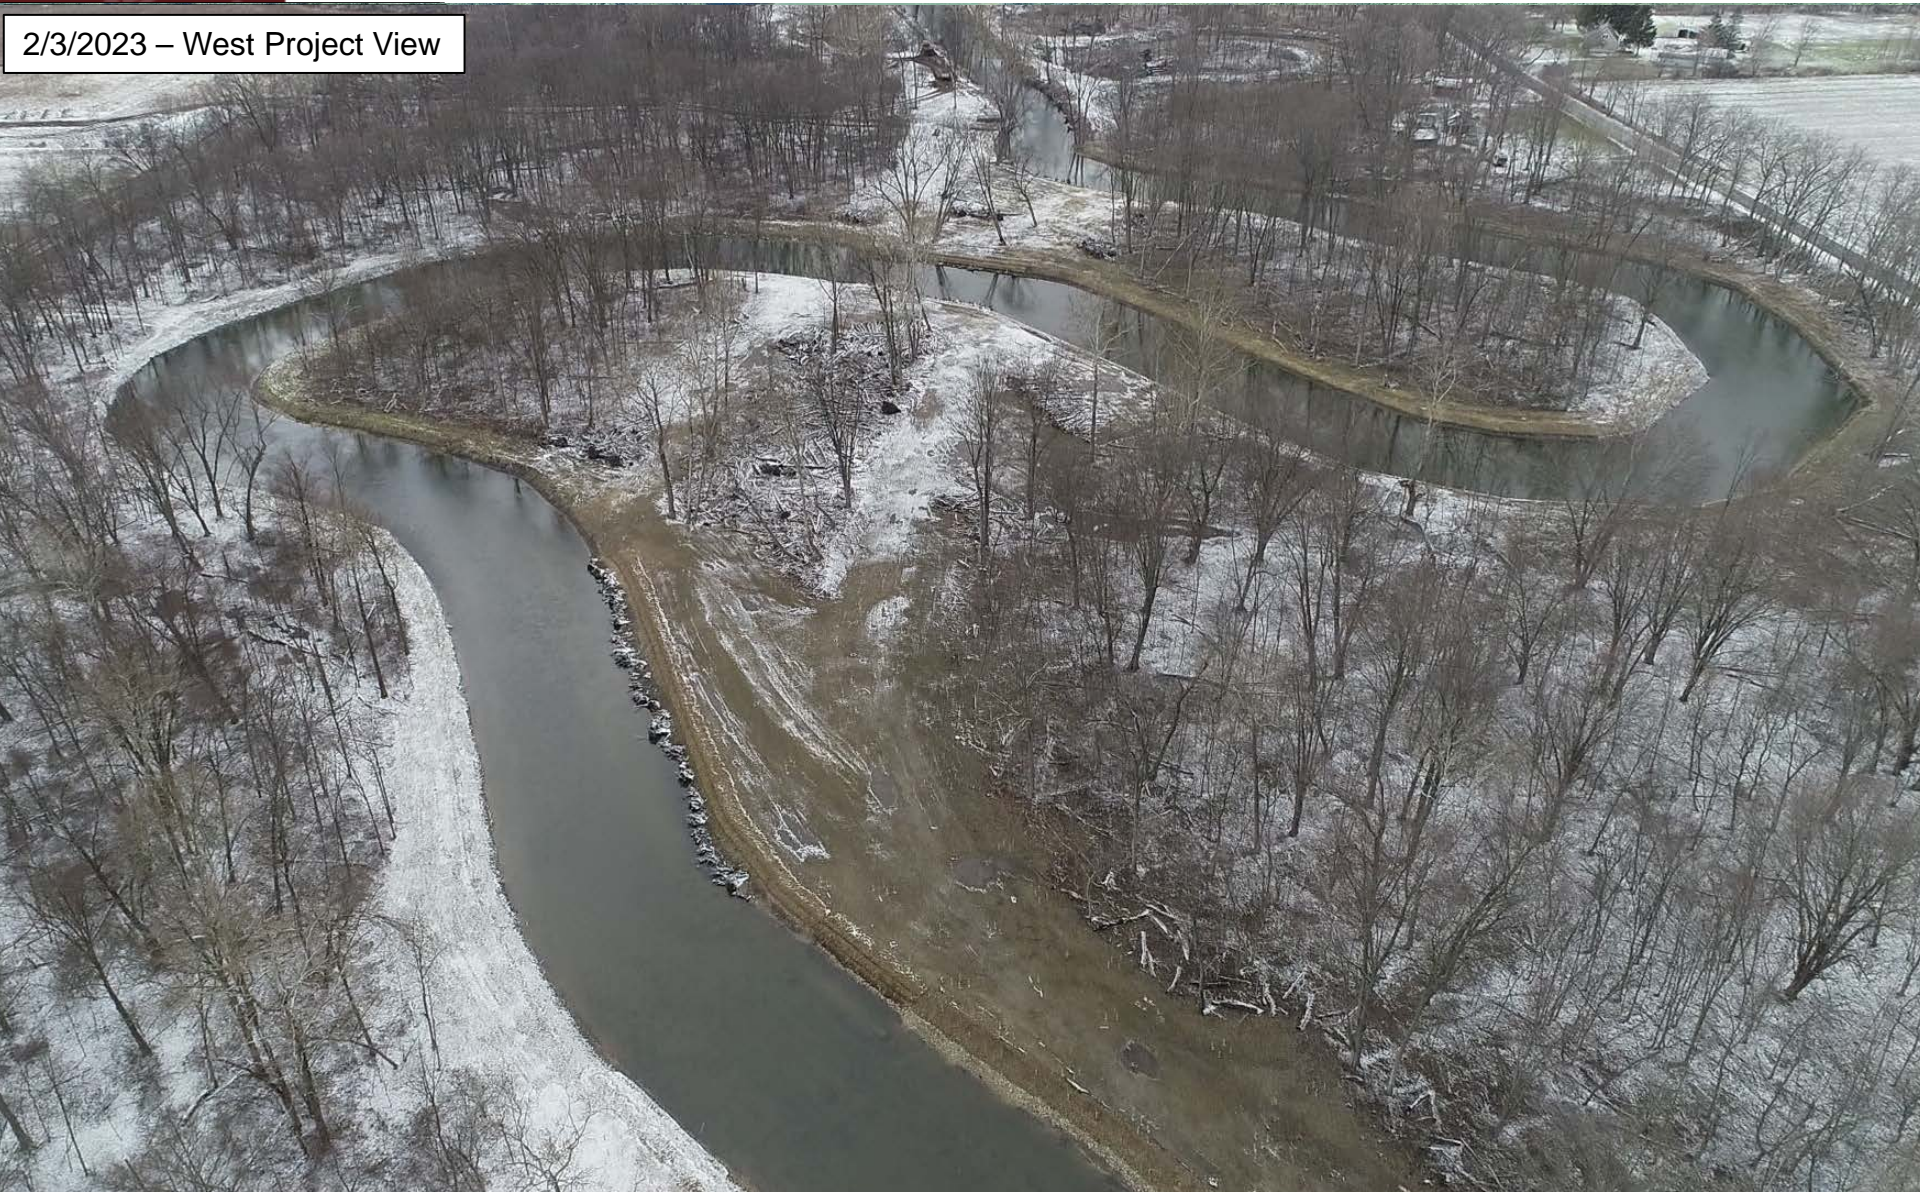
2/3/2023 – West Project View

- Straw & seeding:  
September 9, 2022
- Native shrub, tree, and seed restoration:  
October 24, 2022

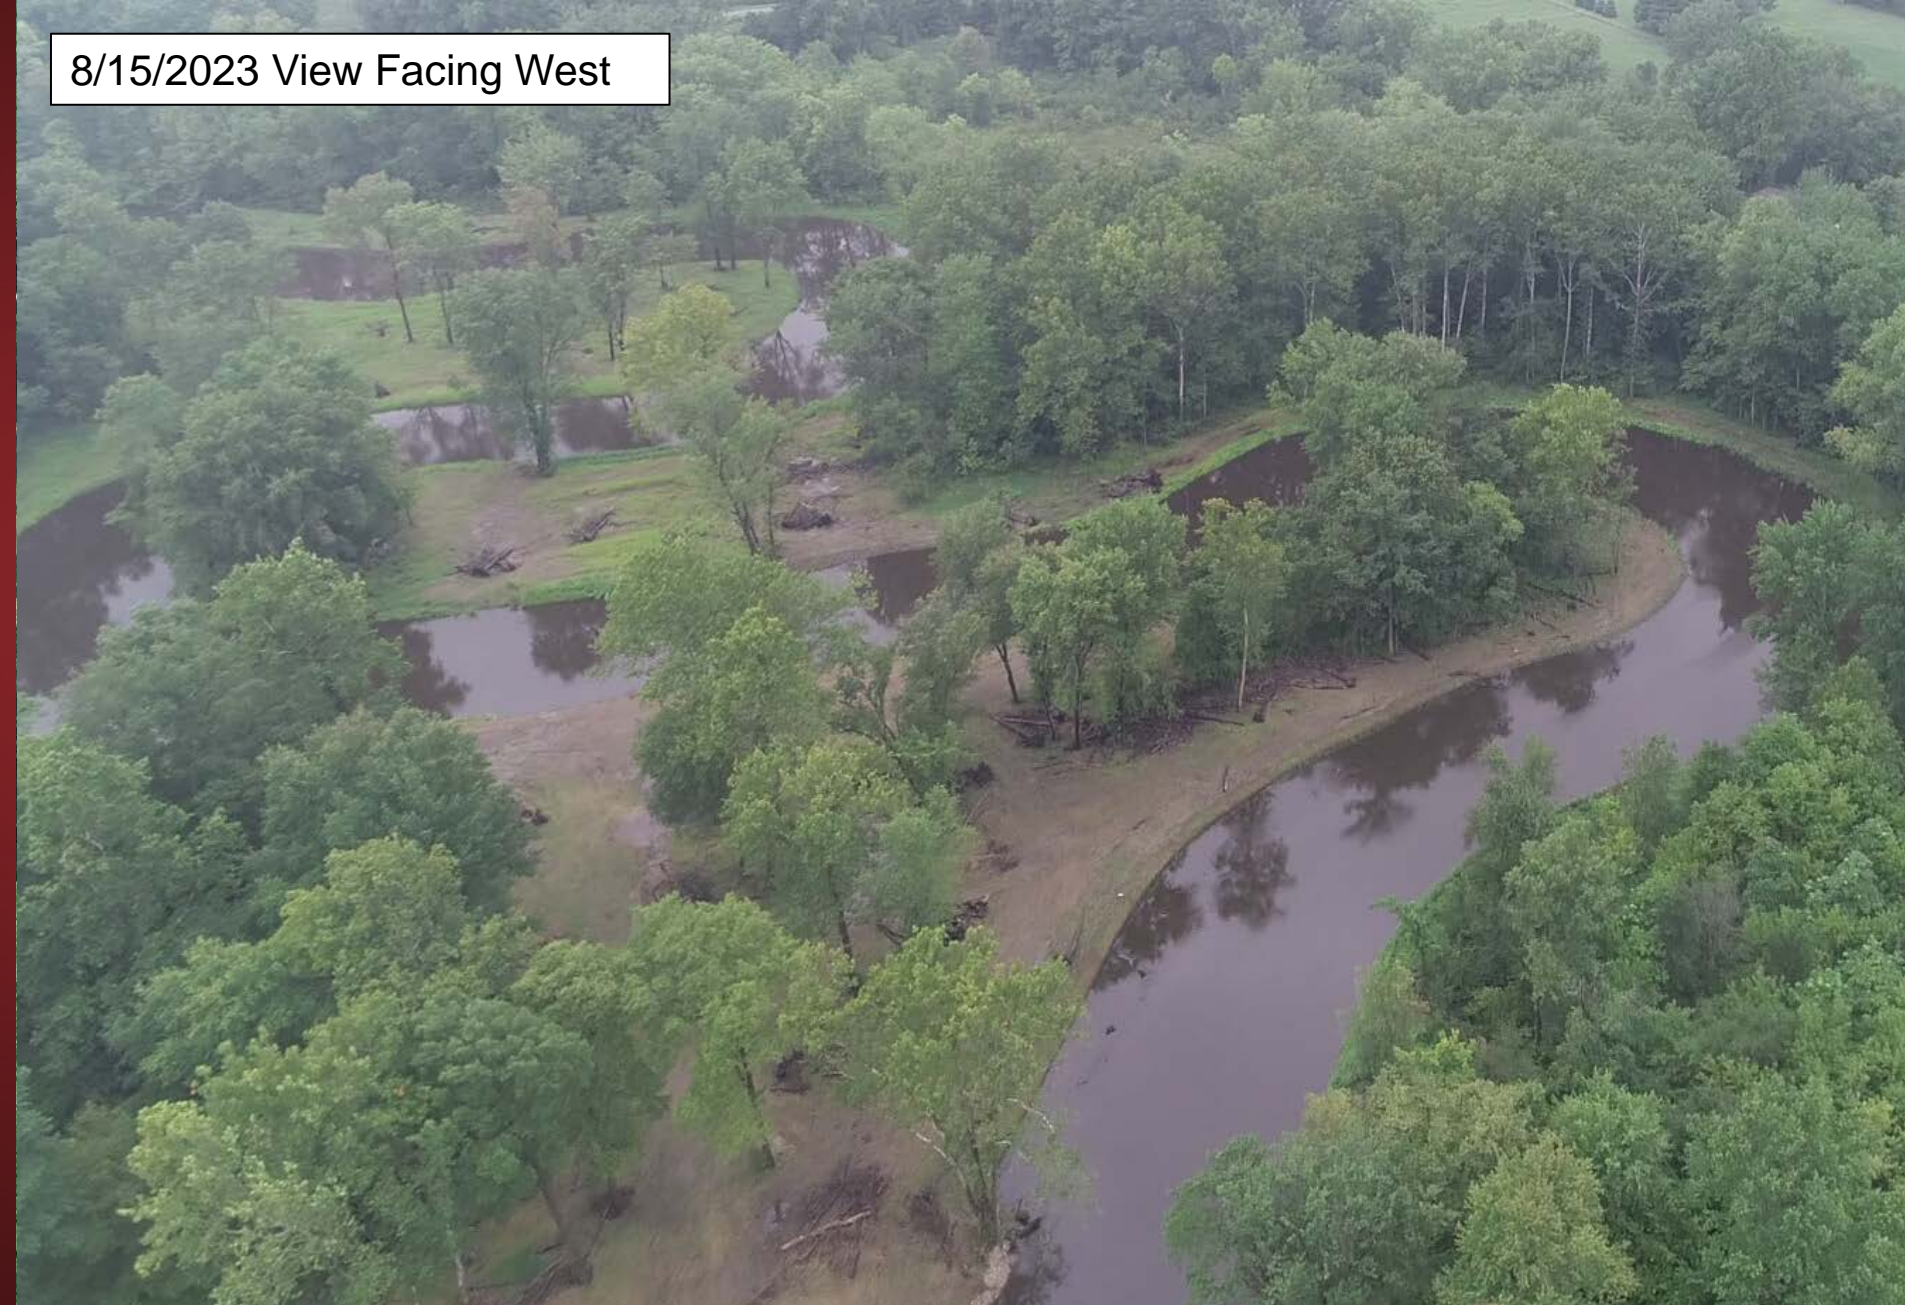
8/15/2023 View Facing West

- Most of the Phase 2 trees, shrubs, and live stakes were planted the last week of October 2023.
  - Seeding and tree replacements will occur in areas where needed
  - Now that both phases complete, 0.66 miles of dredged, straightened, and floodplain disconnected river has been restored to 1.29 miles of historic sinuosity with re-connection to the floodplains
  - Hydrology is being restored to over 53 acres of wetlands within the floodplains
  - Enhanced habitats for plant and animal species of cultural significance to the Pokagon Band
    - Niche habitats for migratory fish and needed spawning, feeding, and fry habitat
    - Migratory fish for the first time in almost a century
  - More resilient to climate change
  - Additional flood storage and reduced sedimentation within the river
